The Establishment of the Sustainability Performance Indicators for Wetland Ecological Project: Using Construction Inspection Phase as Example

Table 2 Results of SPI site test over water purification work on artificial wetlands along river in Hsinchu City

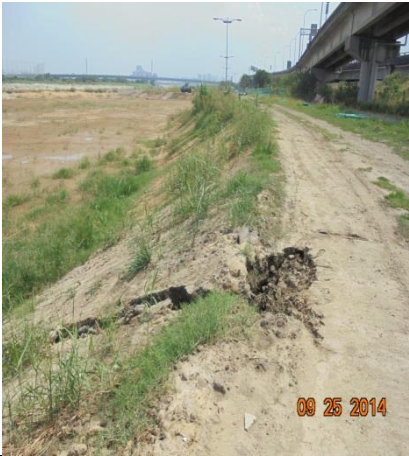
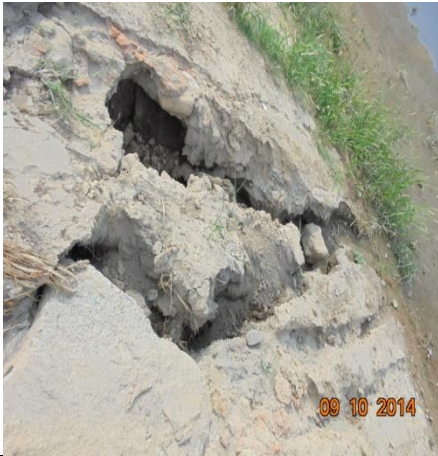
Area of pond /river slope collapse	Area of collapse at 1.6m2	Roller tape	Repair completed within 3 days
Pictures from inspection
